Inspection Report

Mine Name: White Cap #8

Operator Name: Gypsum Resource Development

Permit number: S0150047

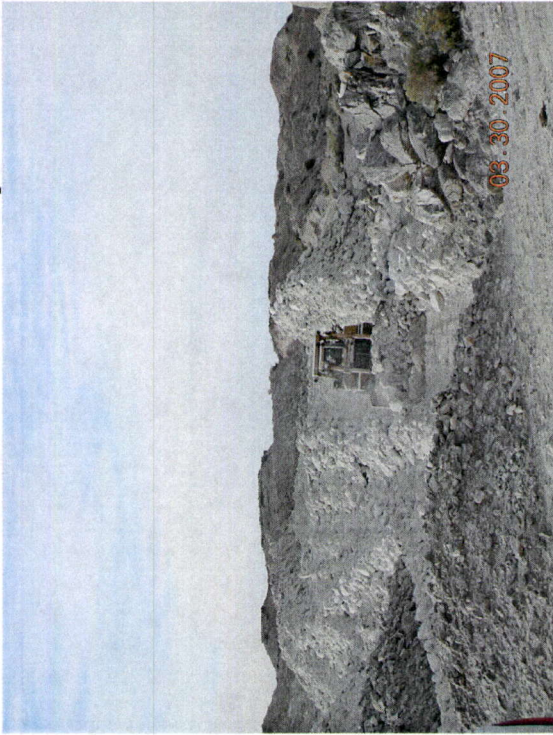
Photo 1. D-9 dozer pushing a gypsum stockpile back into the pit.

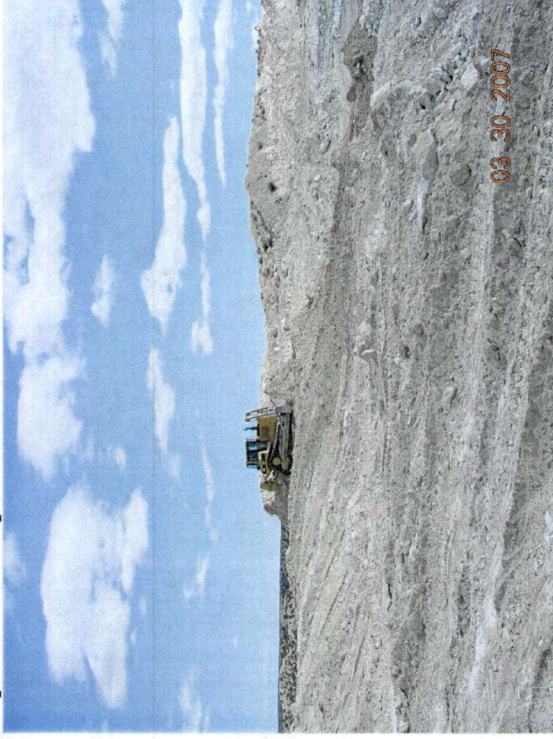
Photo 3. The dozer is pushing in berms of soil and overburden from the east side of the quarry.

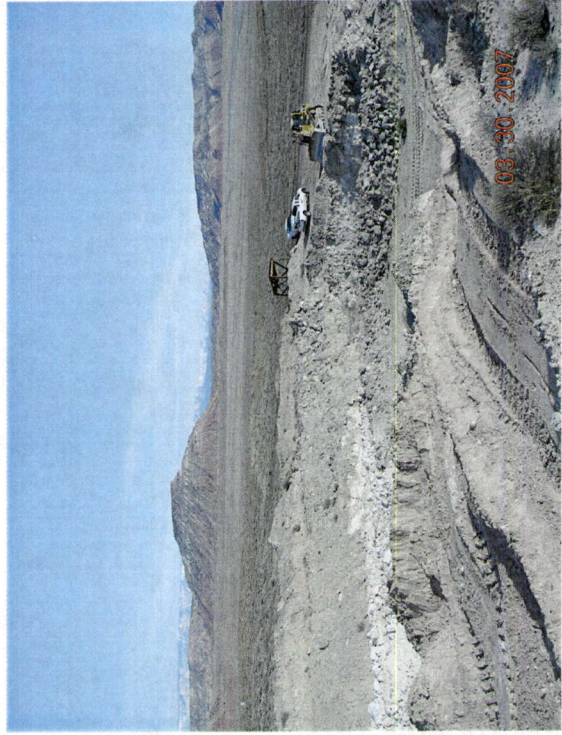
Photo 2. The mine pit is on the center right of the photo and is close to a county road.

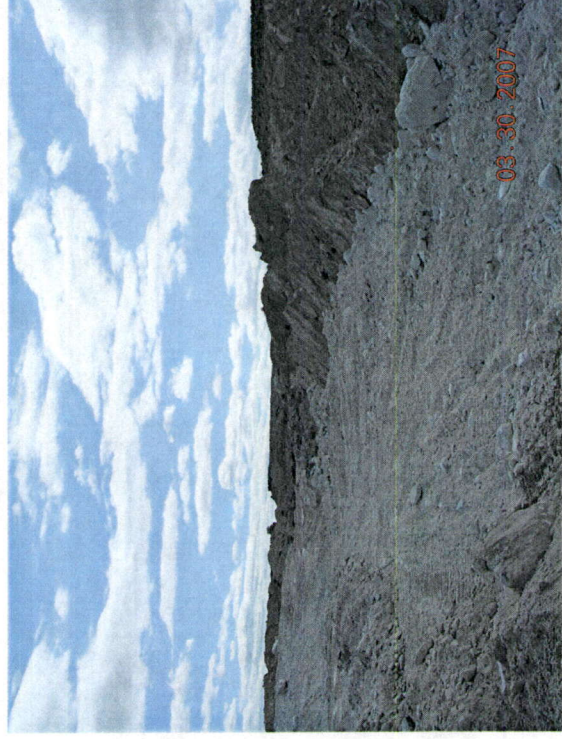
The pit area was still low enough that it would impound water when I left. Additional material needed to be graded into this area to give positive drainage.

Photo 4. This shows the pit area several hours after Photos 1 and 2 were taken. The pit was nearly filled at this point.
